Public Landscapes/Parks/Memorials

Reston Town Center Fountain Plaza Renovation

Reston, Virginia

PINNACLE AWARD RECIPIENT

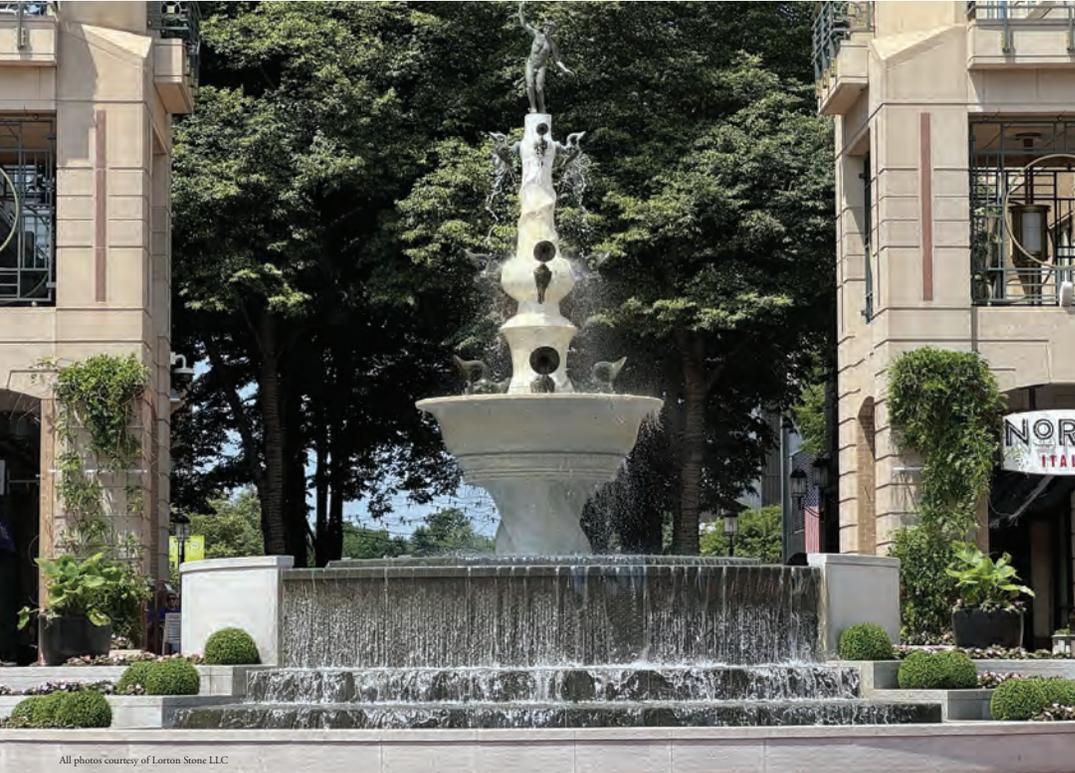
The Mercury Fountain has been the heart of Reston Town Center since the early 1990s. The fountain was carved from Carrara marble and topped with a bronze statue of Mercury. Thirty years of weather resulted in severe deterioration of the marble. A 2023 renovation of the fountain plaza included replacement of the deteriorated fountain bowl and pedestal, as well as a redesign of the lower fountain base. The new contemporary design incorporates tiered splash ledges, and a patterned feature wall fabricated from Jet Mist granite, as well as perimeter walls fabricated from Bethel White granite. Other enhancements to the plaza included improved seating and circulation as well as new landscaping.

Accurate replication of the Mercury Fountain's twisted form was accomplished using two methods. First, the fountain was laser-scanned to develop a 3D digital model of the pedestal and bowl which was used to develop the CNC programming. Second, molds were made of the existing pedestal and used to cast a full-size model that was shipped to the fabricator and used for refining the details of the pedestal. The CNC work took roughly six weeks to carve out the forms of the pedestal and bowl.

The new feature wall included a unique caduceus pattern that was sandblasted into the dark granite. The pattern mimics the caduceus staff held by Mercury at the top of the fountain.

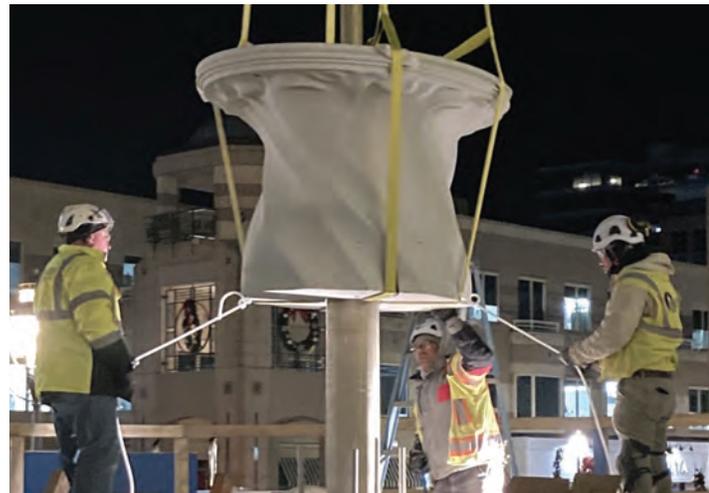
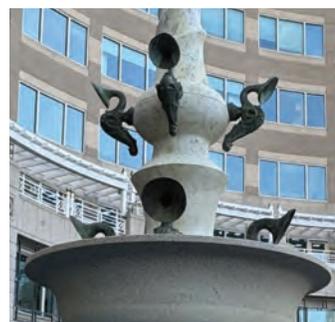
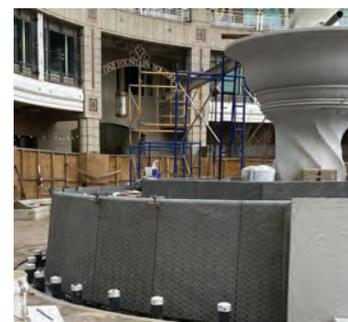
Reinstallation of the Mercury Fountain elements was challenging. Workers had to "thread the needle" using a crane to lower the 6,000 lb. fountain pedestal, the 9,000 lb. bowl, and the original marble topper over the existing supply piping and match the elevations of the piping outlets.
